ACO Access – Rhinocast<sup>®</sup>

Case Study

# Rockhampton Courthouse Complex, Rockhampton Qld

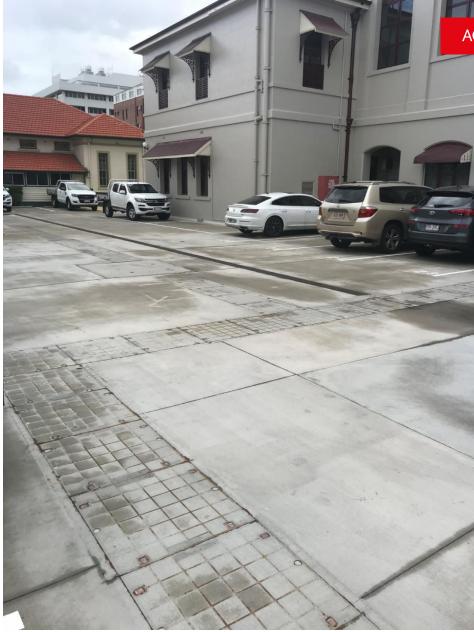
With several heritage restraints, designers were faced with complex issues to resolve, one being the need for continual use of existing service trenches. Designers opted to maintain the existing brick trenches, but create uninterrupted access through a trench run access cover system. Covers needed to withstand the wheel loads of heavy service vehicles that access the car park areas.

- **Rhinocast**<sup>®</sup> ductile iron 92-part trench run
- ACO Technical Services Department was able to provide complete installation details to designers and installers, for the trench run configuration

- Rhinocast<sup>®</sup> access covers are certified to Load Class D (AS 3996)
- An individual cover can be removed to access localised services, or all covers can be removed to ensure complete access to the trench
